Inspection Report Minerals Regulatory Program November 4, 2008

Mine Name: Black Butte

Operator Name: GoldTerra

Permit number: S0150080

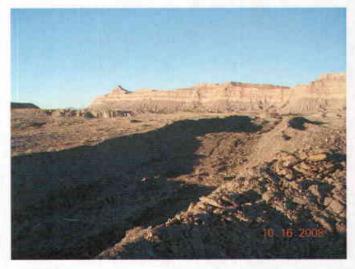
The trenches were mostly about 20 feet wide, but one averaged about 40 feet. The actual widths varied, and these figures underestimate the actual disturbance areas. The trenches were mostly about 3-4 feet deep with deeper and shallower places. A pile of material had been pushed up at the end of each trench with some piles on the sides as well.

Photo 1. This and Photo 2 show two of the trenches.

I had planned to take enforcement action, but the operator's representative, Dan Sheppard, informed by voice and e mail on November 25, 2008, that the trenches have been regraded. The operator needs to seed the disturbed areas, and the Division and operator will need to monitor them for revegetation success. There is not a lot of vegetation in the area, but there is some. I recommended to the operator a seed mix that includes mat saltbush, Castle Valley clover, and Indian ricegrass.

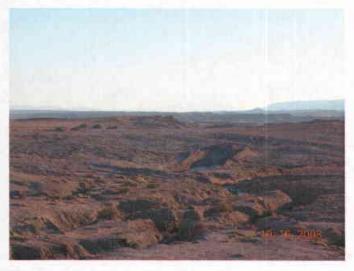
Photo 3. The piles across the center of this photo are associated with trenches.
